Preliminary Assessment Report for Camp Roberts, California

U.S. ARMY ENVIRONMENTAL CENTER
ABERDEEN PROVING GROUND, MARYLAND 21010

ENVIRONMENTAL RESOURCES MANAGEMENT, INC. 855 SPRINGDALE DRIVE EXTON, PENNSYLVANIA 19341

24 OCTOBER 1995

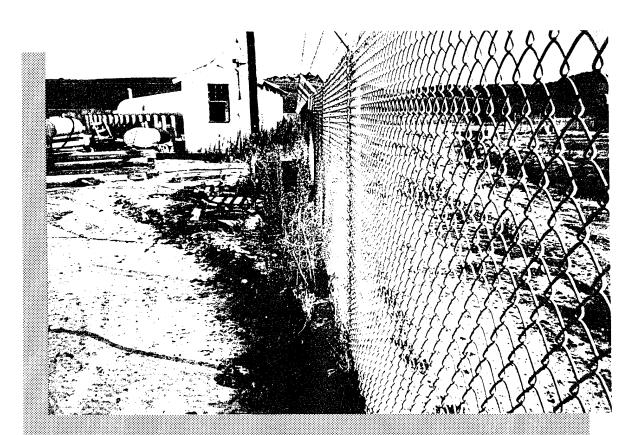
Prior to 1976, used battery acid was neutralized and poured into a drainage ditch (Appendix F, Photograph 1). The volume and frequency of this discharge was low (Ref. 13) [attempts to accurately characterize the volume of neutralized acid discharged were unsuccessful (Ref. 39)]. No visible signs of this practice were found during the site visit. From 1976 to the mid-1980s, battery acid was neutralized in a vat and then discharged into the sanitary sewer. Battery wastes were not tested for heavy metal concentration prior to neutralization and disposal to the sanitary sewer, as required by RCRA. There were no problems reported at the wastewater treatment plant associated with this operation, though, as referenced earlier (see Section 3.1.2), the sludge drying beds have not been tested for heavy metals. Currently, a contractor removes used batteries and battery acid from the site.

Photograph 1: Old Battery Maintenance Area, located 150m ESE of Bldg. 25012. Neutralized battery acid discharged to culvert seen in right side of picture.

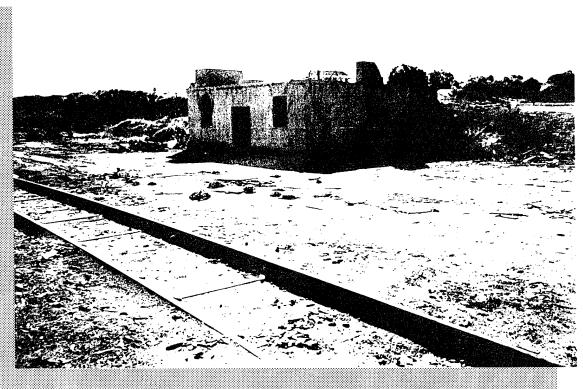
Photograph 2: MATES Vehicle Staging Area.

Photograph 3: MATES Oil/Water Separator.

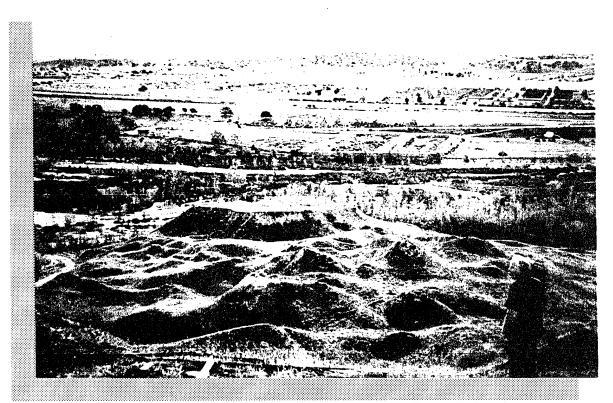
Photograph 6: Looking across possible UXO site above Bldg. 927.

Photograph 7: Possible UXO in field above Bldg. 927.

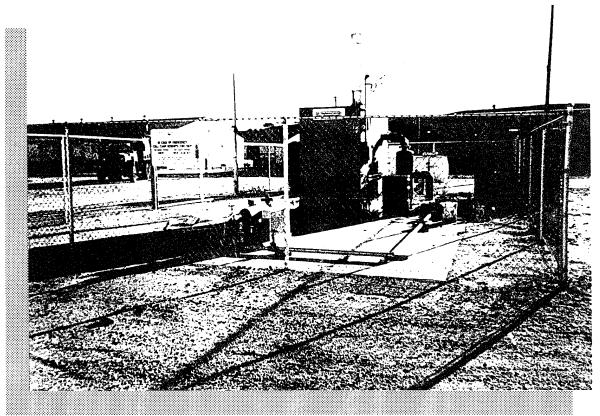
More extensive contamination was found at Tank Site 936 where gasoline was released from two 25,000-gallon USTs that were removed in 1989 (Appendix F, Photograph 10). GEOSYSTEM conducted subsurface investigations and, in 1993, installed an integrated vapor extraction/air sparge system at Tank Site 936 to remove gasoline from the soil and groundwater. As of October 1994, the mass of gasoline removed by the integrated soil/groundwater remediation system was 25,200 pounds (Ref. 10). The remediation action by GEOSYSTEM is ongoing. Recent sampling results are found in Appendix E.

Photograph 10: Vapor Extraction/Air Sparge System at Tank Site 936.

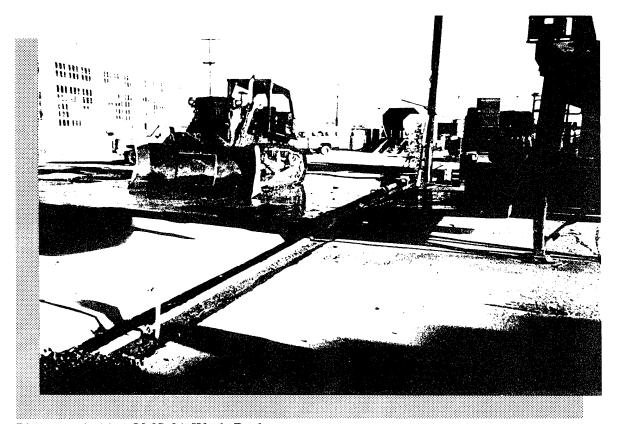
The OMS was located at Bldg. 6410 until 1977/78 when it moved to its current location. The facilities include wash racks (Appendix F, Photograph 11), an old locomotive repair shop, and the main maintenance building. Past and present methods for battery acid disposal at the OMS-21 are the same as those described for the MATES. Past and current practices regarding solvents and waste oil are also essentially identical to those described for the MATES (see Section 3.1.6). The OMS-21 also employs the analytical testing of engine oil to determine oil change requirements (Appendix F, Photographs 12 and 13).

Photograph 11: OMS-21 Wash Rack.

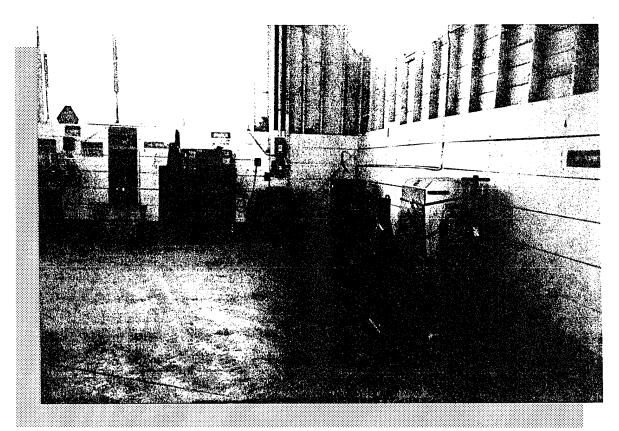
Photograph 13: Maintenance bays inside OMS-21.

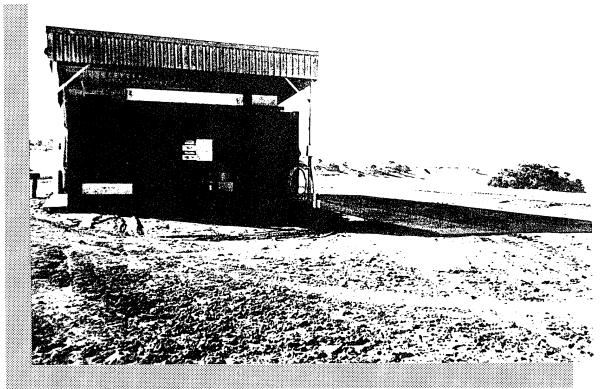
Nine buried drums were discovered southwest of Bldg. 7026 during excavation for a hazardous materials/hazardous waste accumulation facility in November 1993 (Appendix F, Photograph 14). One soil sample was taken at the site and analyzed for total petroleum hydrocarbons (TPH), semi-volatile organic compounds (SVOCs), and metals. Lead was the only detected compound or metal in the sample, the concentration of which was 40 mg/kg (Ref. 19). No further action was taken to identify the extent of this drum burial area, nor to

Photograph 14: UDLP Hazardous Wastes/Materials Storage Area. Buried waste drum area to far right of photo.

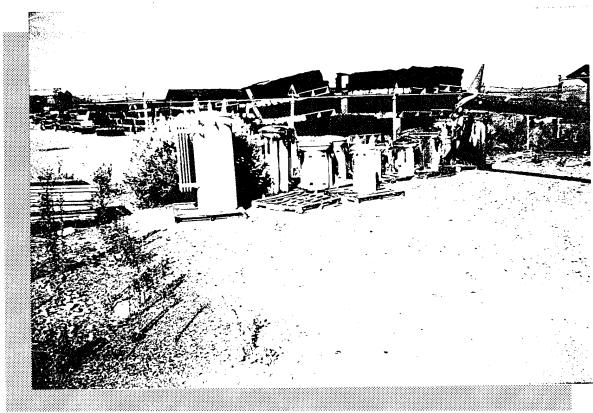
- The open storage of deteriorated transformers labelled as containing Polychlorinated Biphenyls (PCBs) in the Engineering Yard. This deficiency, stressed in a 1983 PA, represents a serious ongoing compliance violation and poses the significant potential for a CERCLA release.
- The open burning/open demolition (OB/OD) areas, particularly Range Y39, used extensively until 1993.
- The buried drums in the United Defense Limited Partnership (UDLP) area of operations; the site has yet to be fully characterized or investigated.

- (3) Electrical Transformers (see Appendix F, Photographs 15 and 16). Transformers, which are potential sources of PCBs, are staged in two areas of the Engineering Yard. Some are new (of these, some are marked non-PCB; according to Mr. Duke, all are non-PCB). There are numerous old and unserviceable transformers stored in the open with no containment and no overhead cover. Many are labelled as containing PCBs. Many are unlabelled, but due to their presumed age, they may contain PCBs. Due to the deteriorated condition of many of these transformers, leaks are a distinct possibility, though no leaks were visibly apparent. The transformers pose serious compliance violations and the potential for a release of CERCLA contaminants.

Photograph 15: Old/New PCB Transformers, north of Bldg. 6418.

Photograph 16: Old/New PCB Transformers, north of Bldg. 6418.

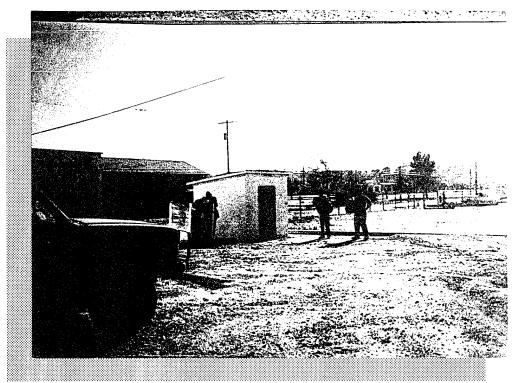
Photograph 17: Hazardous Waste Storage Container and Old Pesticide Storage Area, Engineering Yard.

Photograph 18: Old asbestos (assumed) covered water tanks, Engineering Yard.

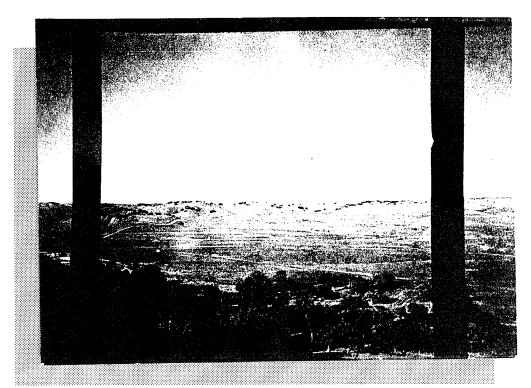
CERCLA releases may have occurred at the firing points (propellant burns and explosives constituents) and in the range impact areas (explosives constituents, heavy metals) (Appendix F, Photographs 24 and 25). There is no record of comprehensive sampling for such releases nor is there any known evidence of CERCLA releases. The evidence suggests that even if releases from the impact areas were to reach the water table, they would not be present in hazardous concentrations (due to the widely dispersed nature of potential releases). Releases from firing points present a greater potential for an environmentally significant release because potential contamination would be more concentrated. During the site visit, representative firing points were observed. No evidence of contamination or environmental degradation was visible. Given the limited and intermittent use of these firing points (Ref. 1), the potential for CERCLA releases is minimal.

Photograph 25: Main Impact Area.
